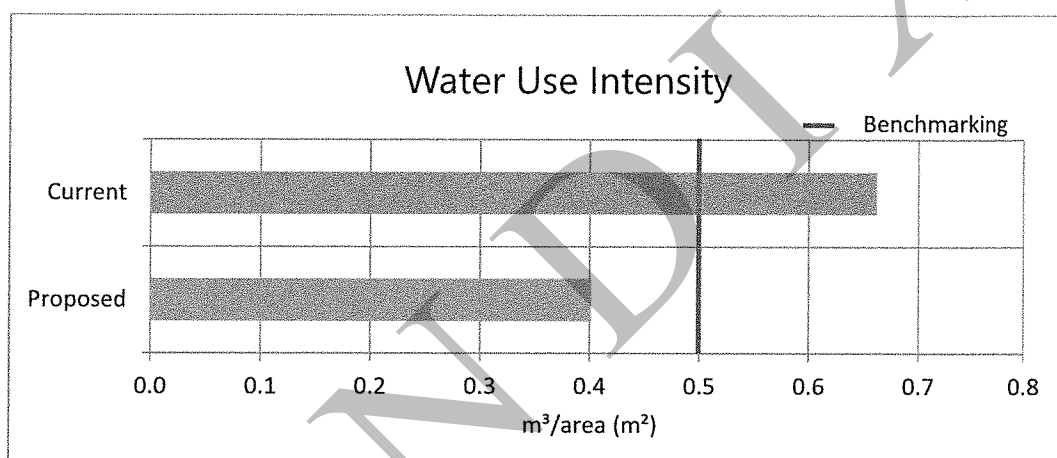
The building's water use intensity is benchmarked in the figure below against other similar buildings with similar characteristics (facility type and use), based on our previous auditing and measurement and verification (M&V) experience over the past 10 years.

The building has a water use intensity of $0.66 \text{ m}^3/\text{area (m}^2\text{)}$; the average water-use intensity was $0.48 \text{ m}^3/\text{area (m}^2\text{)}$. In the figure below, a lower value represents a building that is more water efficient.

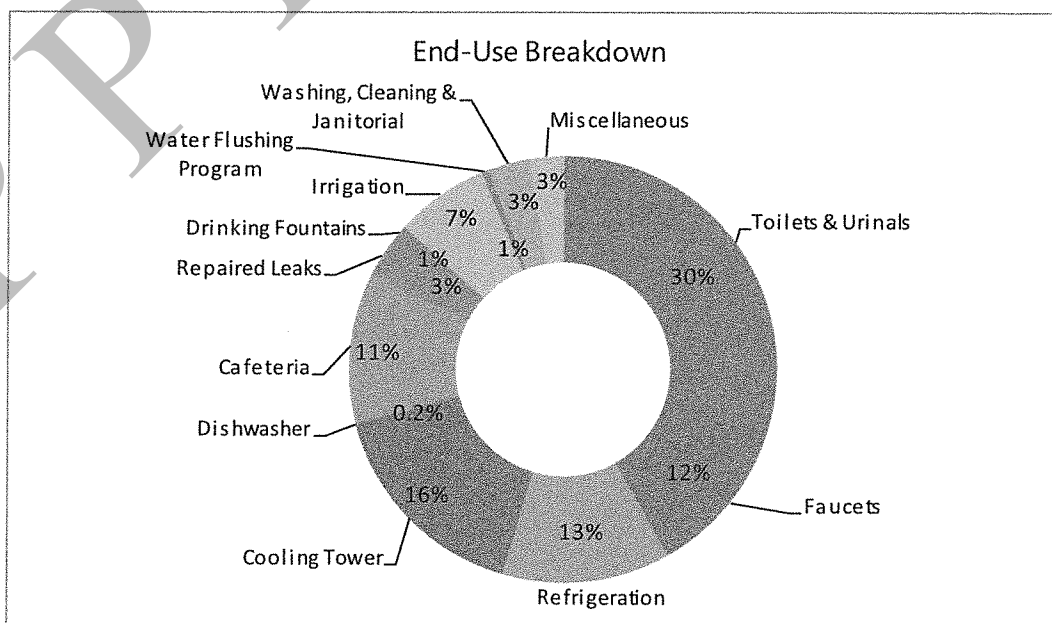
The following graph gives an approximate end-use breakdown of water, based on our observations onsite:

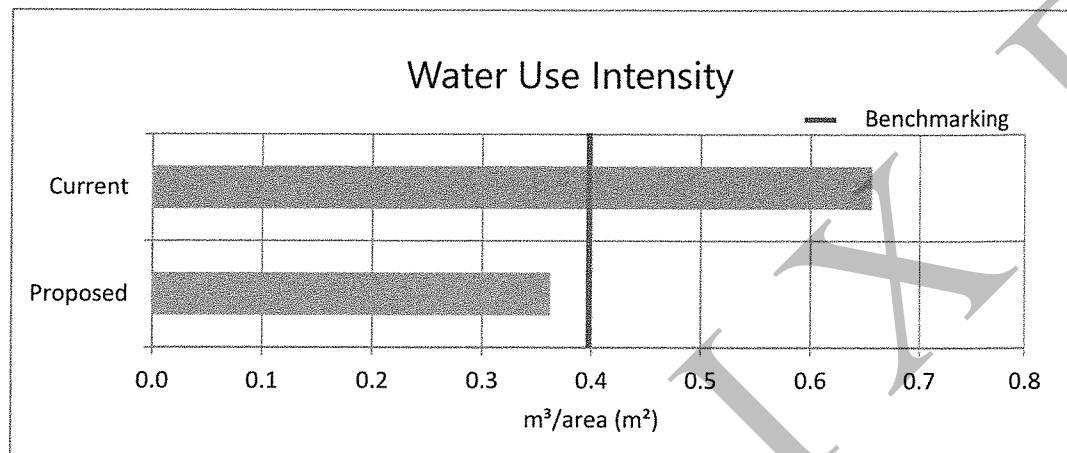
The building has a water use intensity of 0.66 m³/area (m²); the average water-use intensity was 0.40 m³/area (m²). In the figure below, a lower value represents a building that is more water efficient.

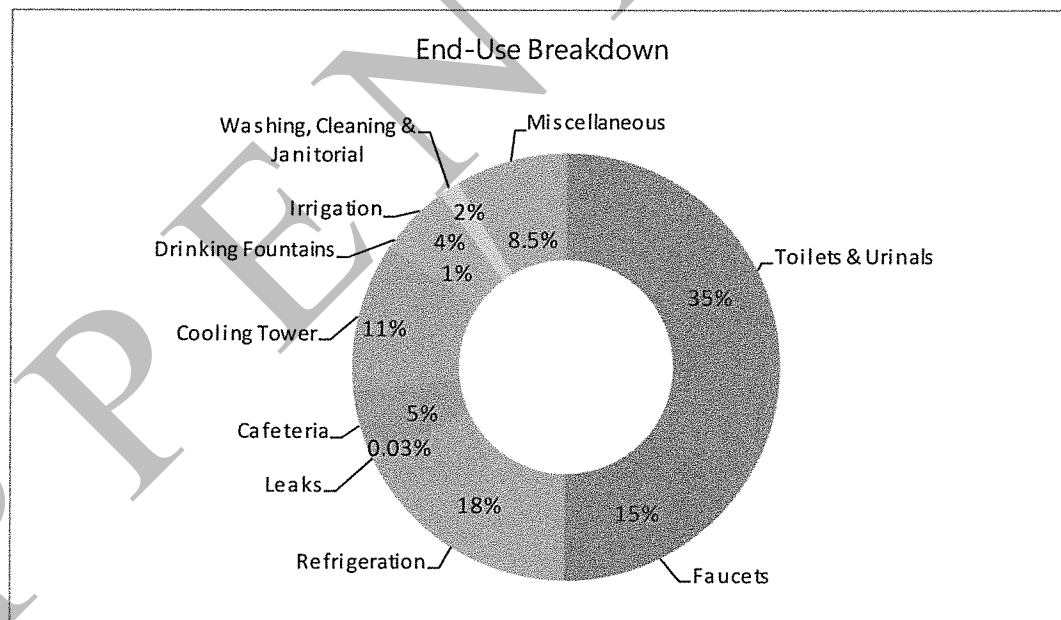
The following graph gives an approximate end-use breakdown of water, based on our observations onsite:

Faucet, toilet and urinal usage accounted for a significant portion (50%) of the overall water consumed in the building.

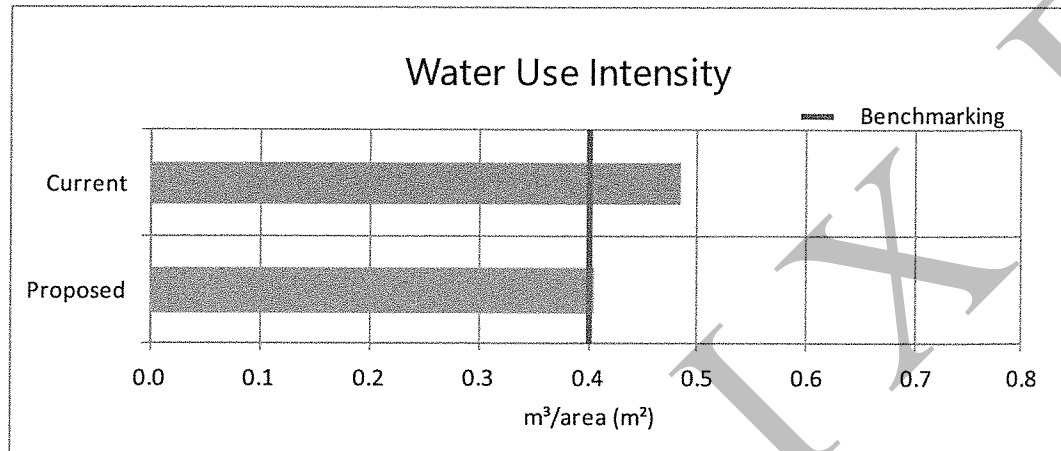
The building has a water use intensity of 0.49 m³/area (m²); the average water-use intensity was 0.40 m³/area (m²). In the figure below, a lower value represents a building that is more water efficient.

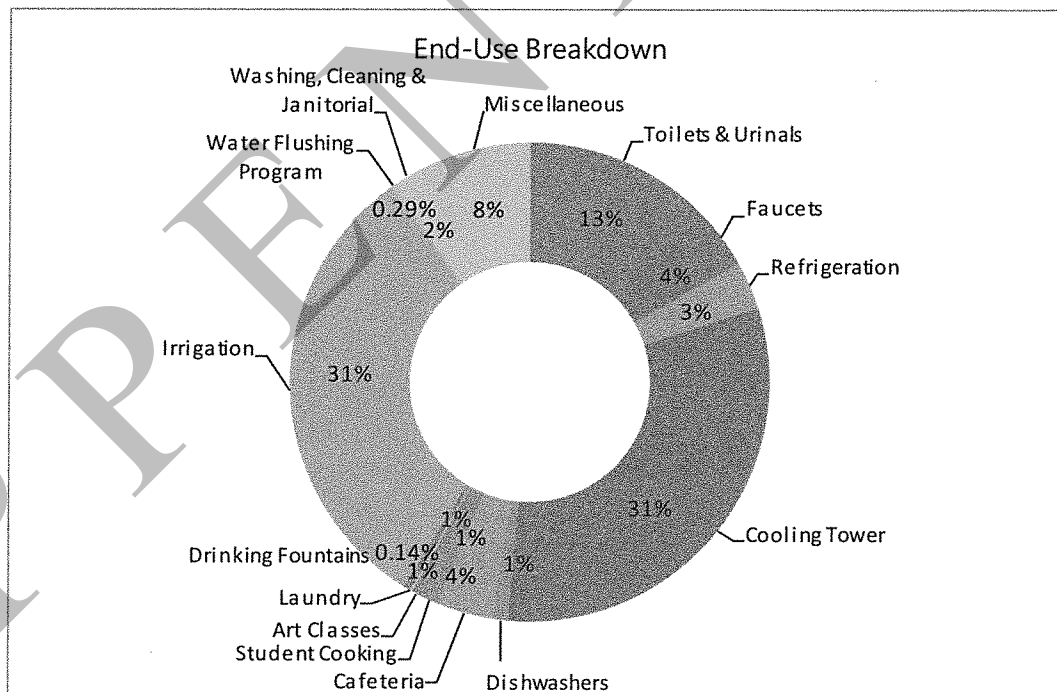
The following graph gives an approximate end-use breakdown of water, based on our observations onsite:

The cooling tower and irrigation usage accounted for a significant portion (62%) of the overall water consumed in the building.
